✓CORPS OF ENGINEERS, U.S. ARMY
FORT WORTH, TEXAS, DISTRICT
SEPTEMBER 1976

REPORT DOCUMENTATION PAGE		READ INSTRUCTIONS BEFORE COMPLETING FORM
1. REPORT NUMBER	2. GOVT ACCESSION NO.	3. RECIPIENT'S CATALOG NUMBER
	AD-A088633	
4. TITLE (and Subtitle)		5. TYPE OF REPORT & PERIOD COVERED
Flood Plain Information Colorado River-Onion Creek to Montopolis Bridge, Austin, Texas.		Flood Plain Information

CORPS OF ENGINEERS, U.S. ARMY
 FORT WORTH, TEXAS, DISTRICT
 WATERSHED & VICINITY MAPS
 COLORADO RIVER
 ONION CREEK TO
 MONTOPOLIS BRIDGE

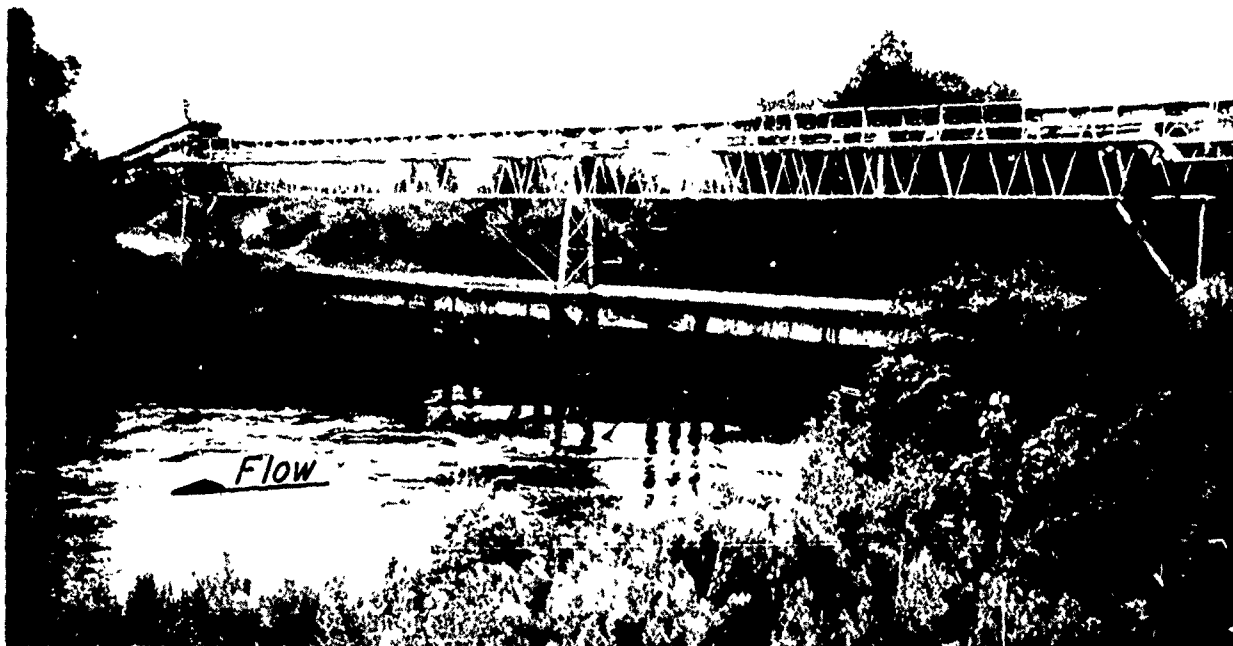
FIGURE 1.--TYPICAL BRIDGES

Upper photograph shows the downstream side of the Bolm Road bridge at river mile 288.74. Lower photograph shows the downstream side of the southbound lane of the U.S. Highway 183 bridge at river mile 290.08.

Obstructions to floodflows. Natural obstructions to floodflows include trees, brush, and other vegetation growing along the streambanks in floodway areas. Manmade encroachments on or over the streams such as dams, bridges, and culverts can also create more extensive flooding than would otherwise occur. Representative obstructions to floodflows are shown in Figure 1.

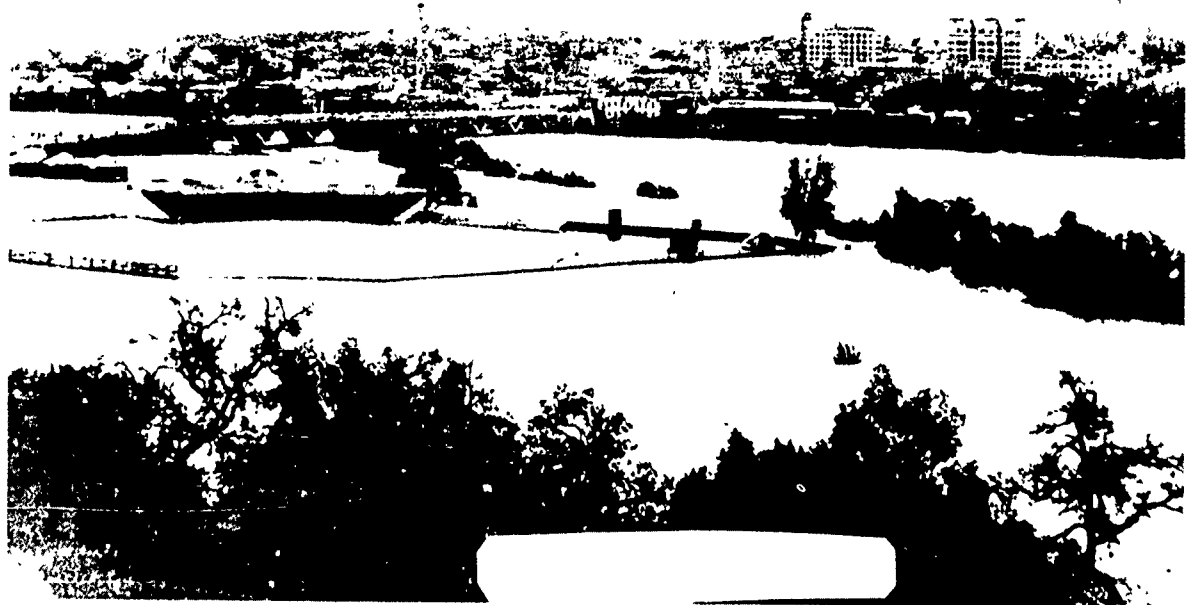
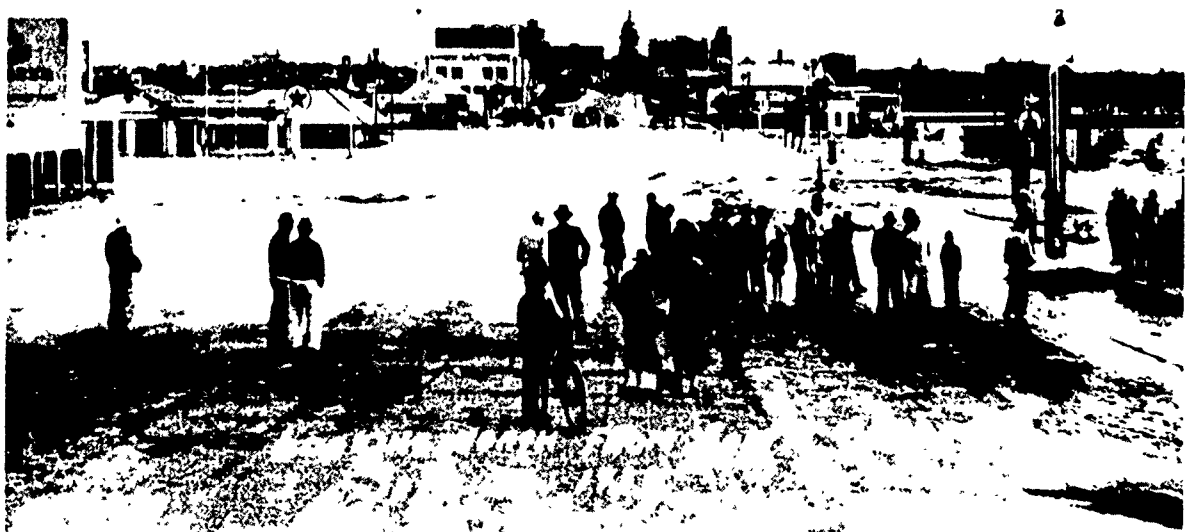
FIGURE 2.--HISTORICAL FLOOD SCENES ON COLORADO RIVER

Upper photograph is view of Congress Avenue Bridge from south bank during December 1913 flood. Lower photograph is scene during September 1936 flood looking north from south bank. (Photos courtesy of Austin-Travis County Collection, Austin, Texas, Public Library.)

Scenes of damages inflicted by historic floods in Austin are shown in Figures 2 and 3 on pages 20 and 21.

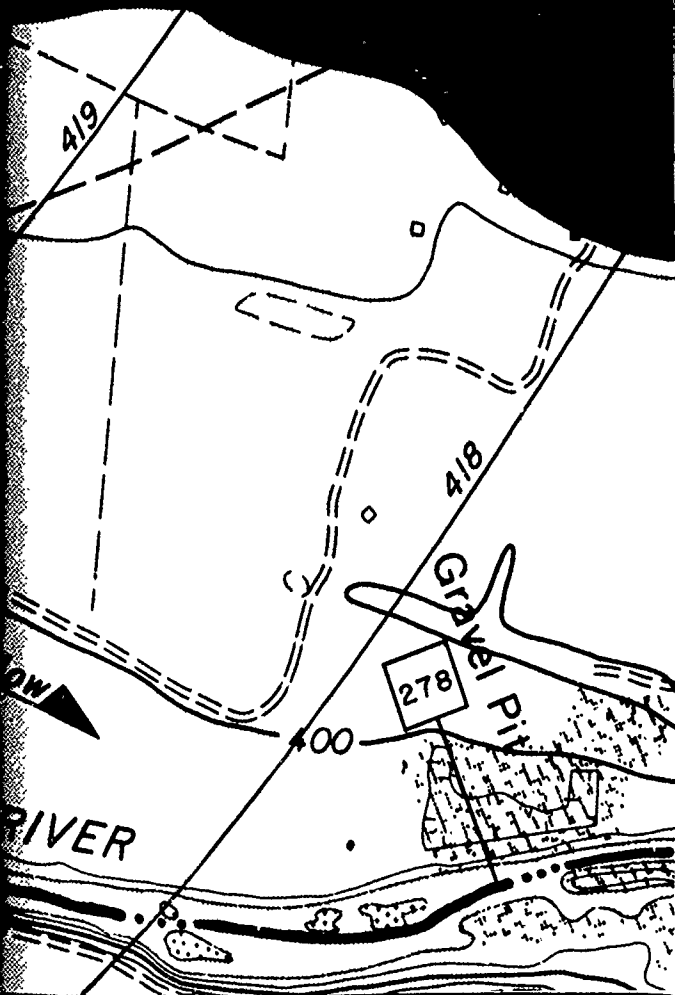
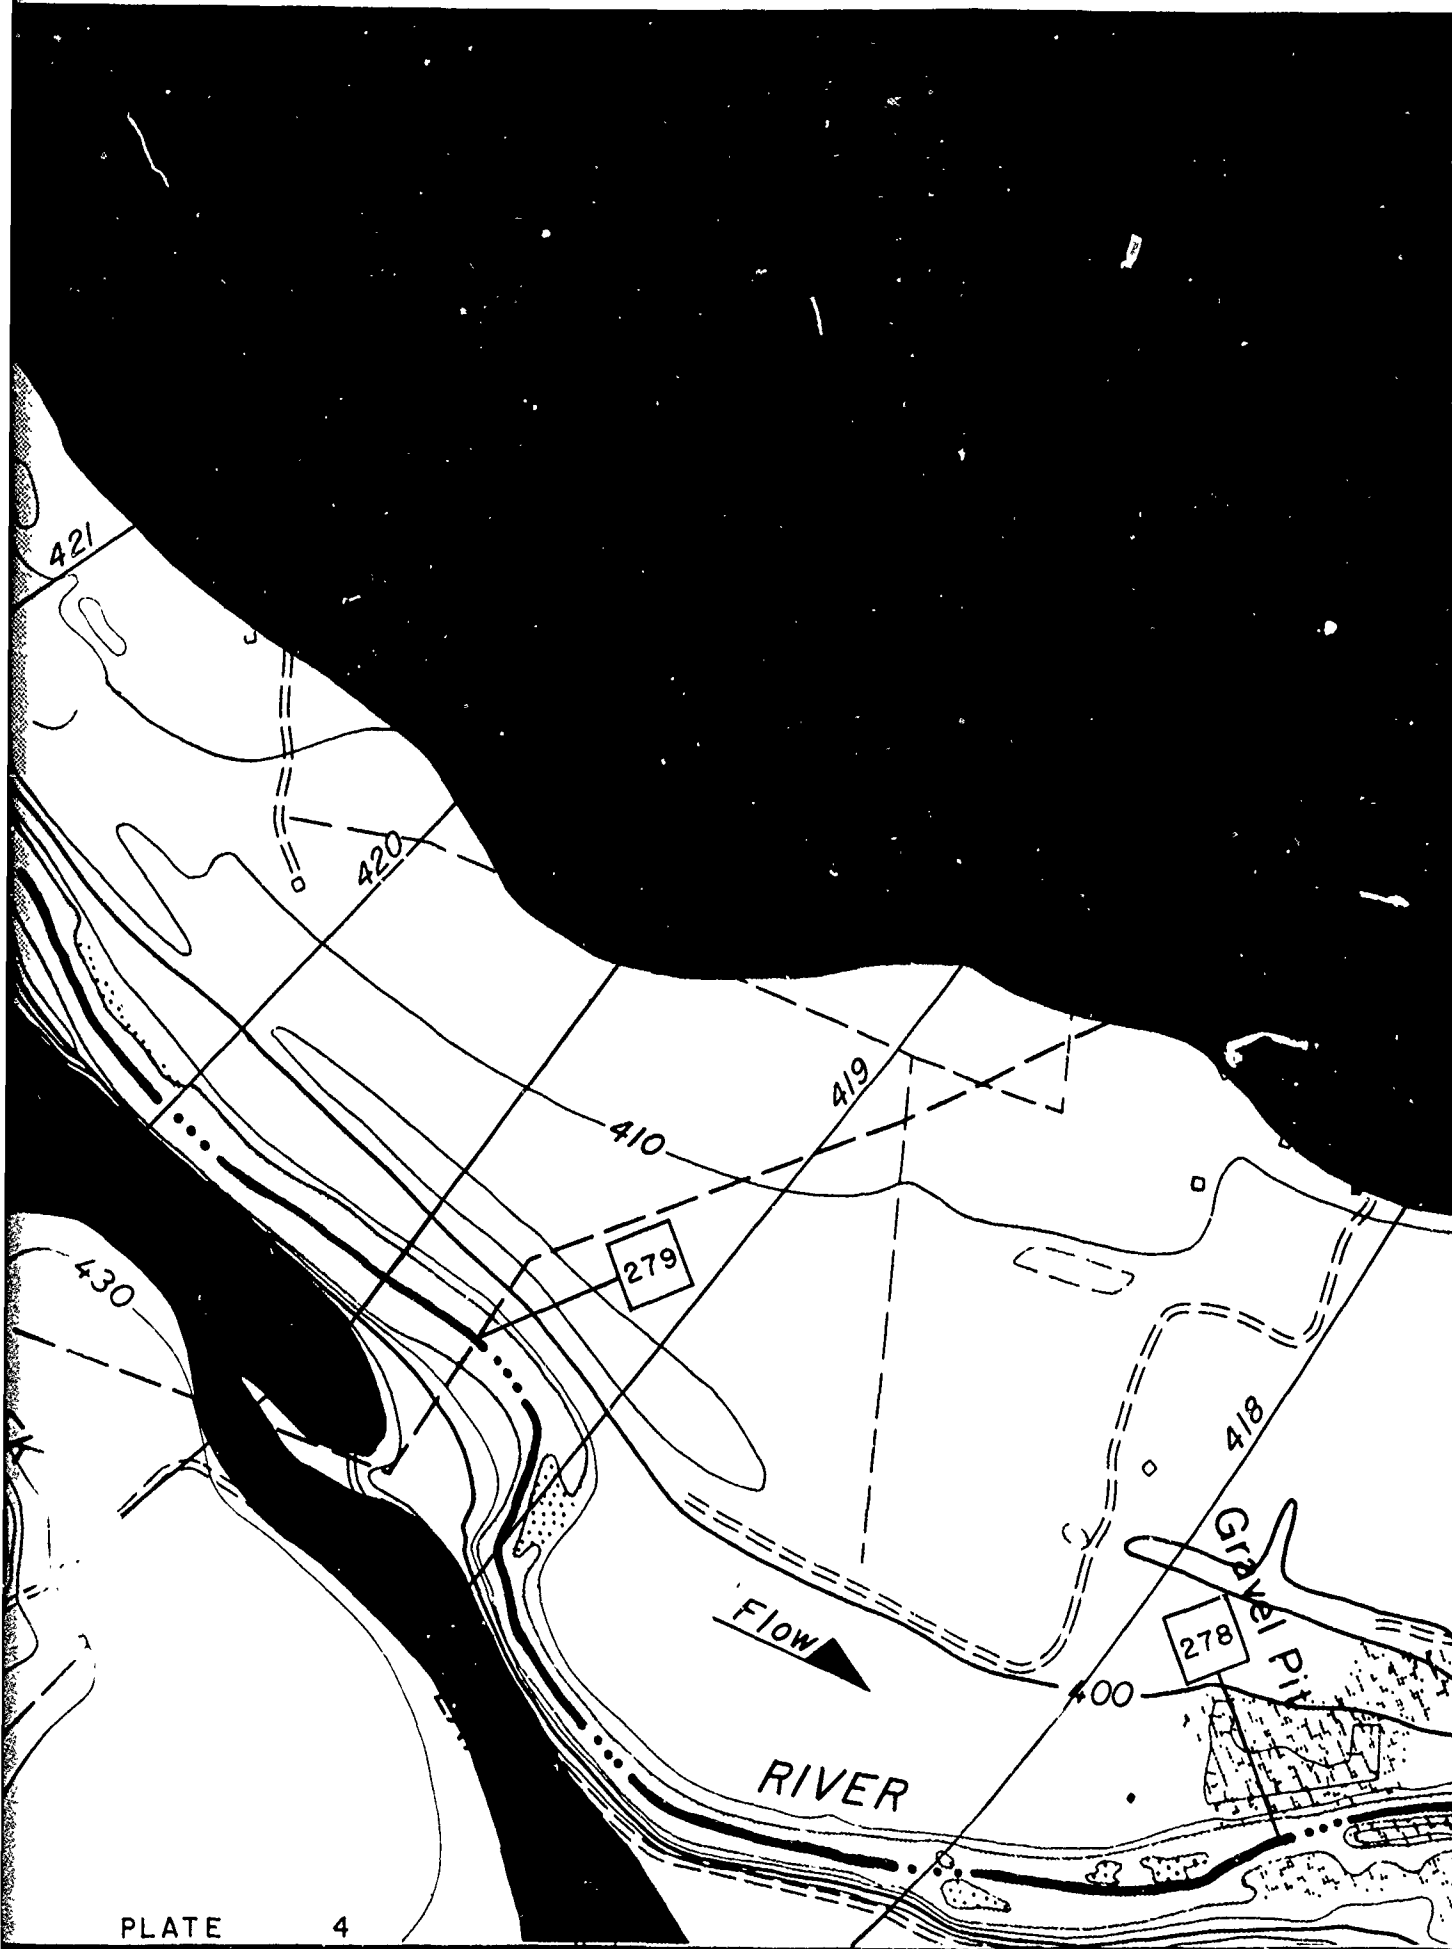
1. LIMITS OF OVERFLOW INDICATED WILL VARY SOME FROM ACTUAL LOCATIONS ON GROUND AS EXPLAINED IN THE REPORT
2. CONTOUR INTERVAL 10 FEET
3. BASE TOPOGRAPHIC MAPS PUBLISHED BY U. S. GEOLOGICAL SURVEY

FLOODED AREAS

COLORADO RIVER

Flooded areas and flood damages. The study areas subject to flooding by the 100-year and 500-year floods are shown on Plates 4 through 13. The 100-year flood would inundate an area of about 4,675 acres along the Colorado River in the reach studied. Depths of flow for any given location can be estimated from the high water profiles shown on Plates 15 and 16. Typical cross sections of the river and flood plains at selected locations are shown on Plate 17. Stream characteristics, topographic maps, aerial mosaics, and valley cross section surveys were used to compute and define the flood situation. Delineations of floodwaters from the streams studied which would "back up" tributaries were not shown for fear of giving the impression of defining the maximum flood plain limits along these streams.
